XJ-S PROJECT CAR

Part 4: A Twist in the Tail. Jim Patten finds that the rear axle cage has also been damaged, and we follow the rear suspension overhaul.

THE CAR:
XJ-S 3.6 coupe manufactured 1988,
VIN: SAJJNAEC3CA15441,
purchased as damaged write-off
December 1997.
Objective: repair, restore, run and upgrade

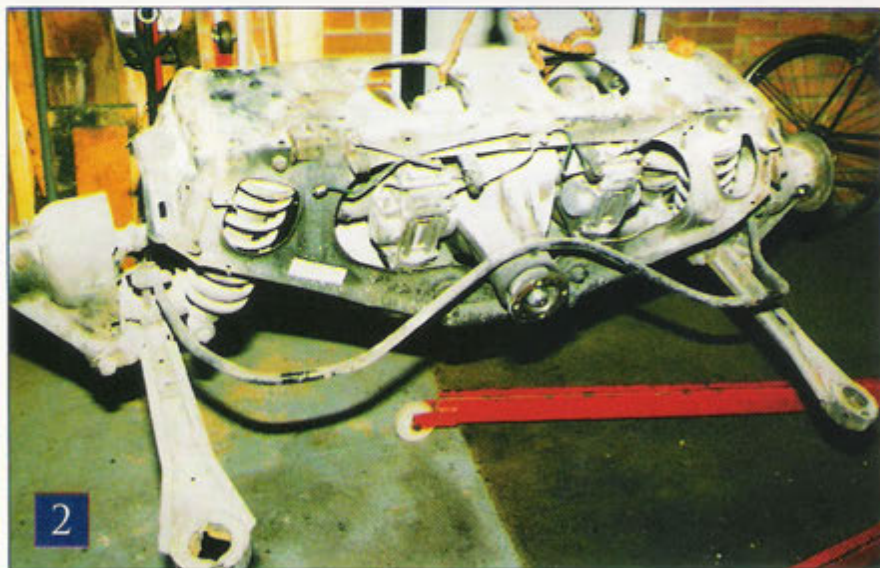
2

car - the angle one of the wheels was at, who wouldn't? It appears that the shunt had pushed the frame against the mountings and these had bent with the force. There was also a crease on the frame itself so we would need a replacement frame at least along with some of the components as well. Paul Banham

As removed from the car: the complete IRS is ready to be taken apart. It's white because of fall-out from Derek's flattening operations in his paintshop.

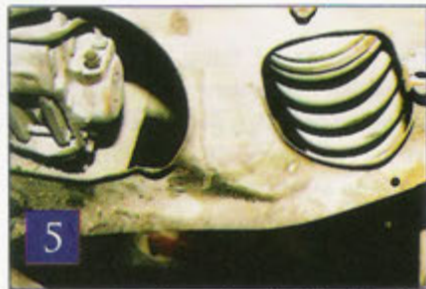
5 See how the frame has buckled in the region between the damper and differential.

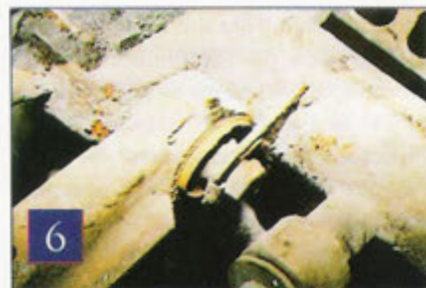
6 This rubber bush has become detached from the metal sleeve so that metal now turns on metal without the resilience of rubber.

the problem of fitting new bushes at home, but means the arm itself, which can be prone to rust, is new as well. All bushes on our car would have had to be replaced anyway as the rubber on one had parted from its steel sleeve.

We had decided not to trust the radius arms, especially as we could obtain complete ready-bushed units from David Manners. This really is a bonus for owners of IRS cars. To have the complete unit available over the counter not only solves

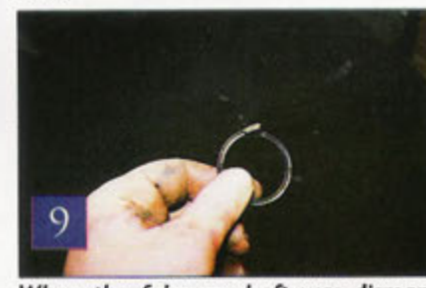
9 When the fulcrum shaft was dismantled, it was found that this grease seal had been split for some time. Grease would soon have vacated the area.

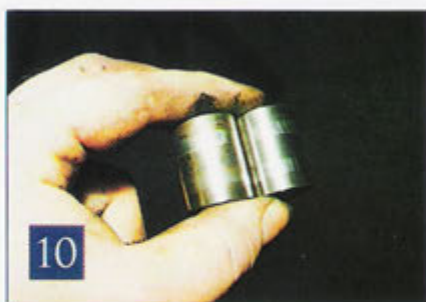
Although showing some slight wear, the inner fulcrum bearing tubes were still in good condition. They were replaced as a precaution, however.

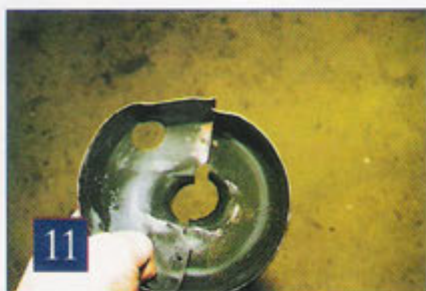
The universal joint cover received some damage but was repairable and would be used again.

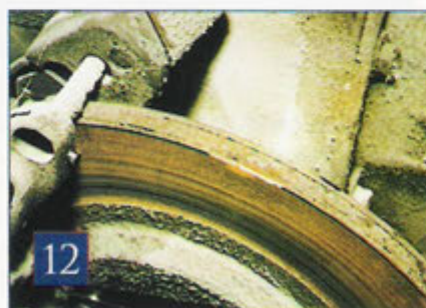
A definite candidate for replacement whether the axle had been stripped or not, these discs are in pretty poor condition.

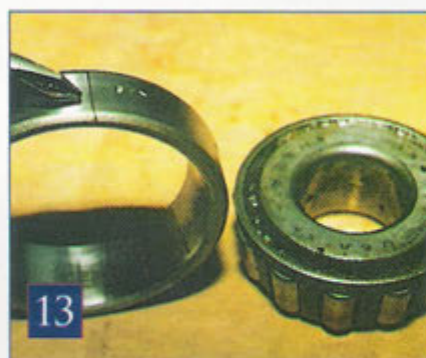
Here's a fault that was unlikely to have been caused by the collision. This outer fulcrum bearing track has cracked. Our work in this area was well timed.

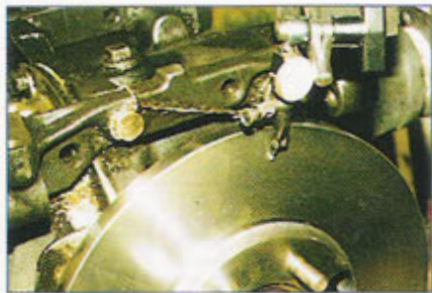
18

A check was made using a dial gauge on the disc to determine if there is any 'run out'.
